Inspection Report

Minerals Regulatory Program

Mine Name: USFS Pass Quarry	Permit Number: S/027/0121
Operator Name: Millard County	Inspection Date: February 5, 2015
Inspector(s): Peter Brinton	Time: early afternoon
Other Participants: none	Mine Status: Reclaimed

Purpose of Inspection: Determine whether partial reclamation was complete, as required

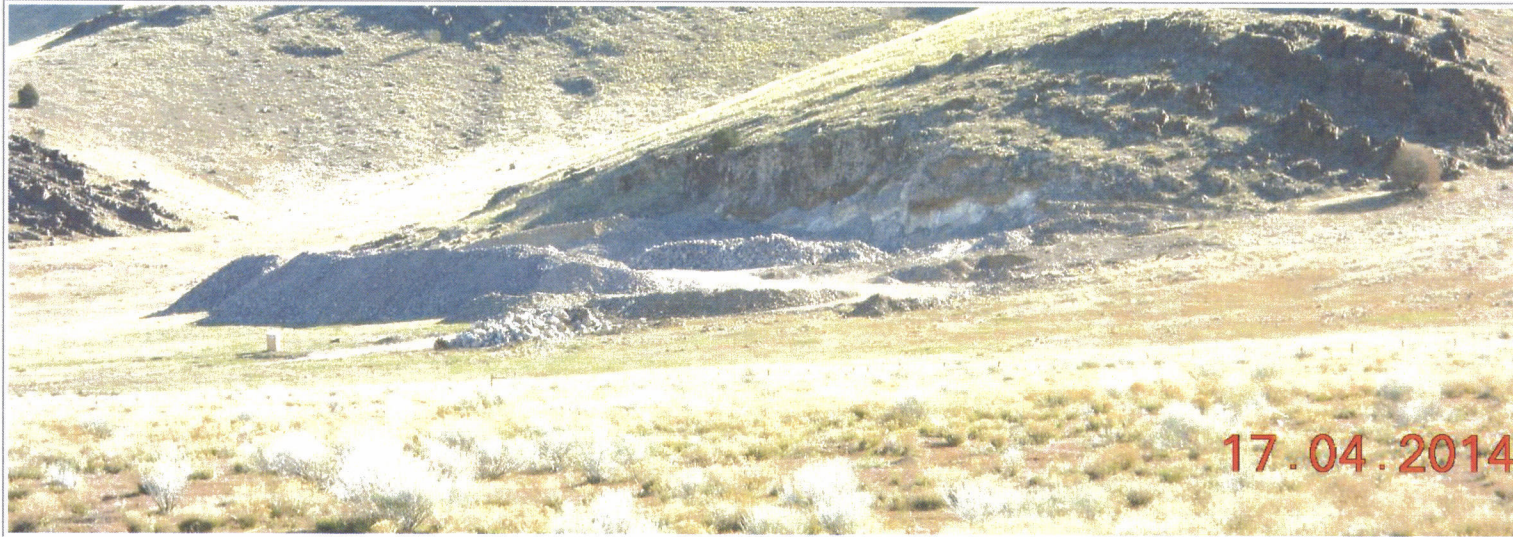
Active operations, looking northeast.

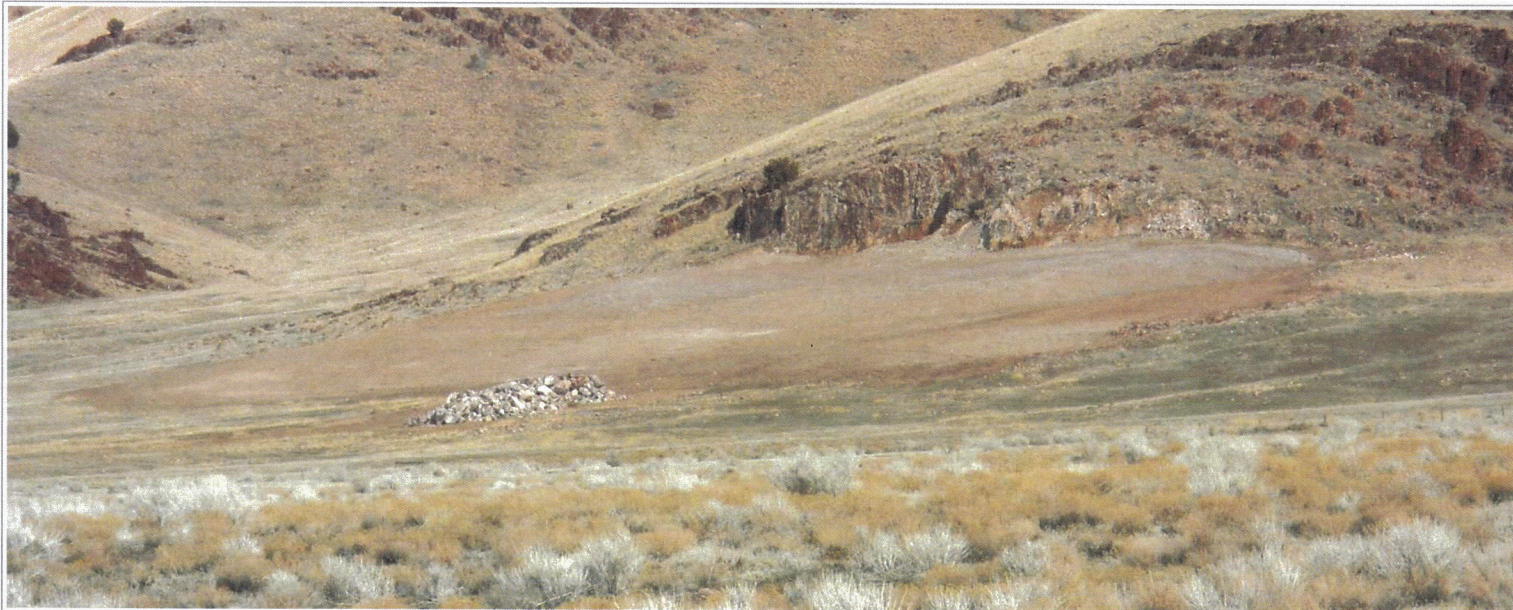
The regraded site, looking northeast. Note the pre-mining outcrops.

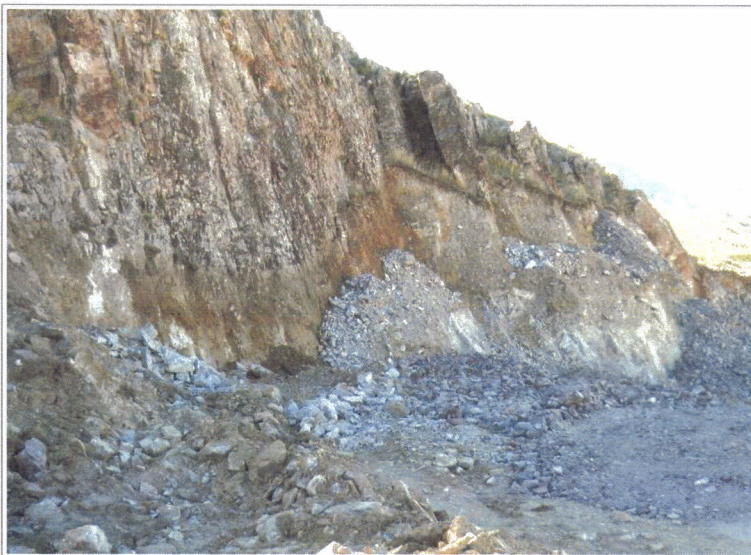
Rock outcrop during active mining. Photo taken April 17, 2014.

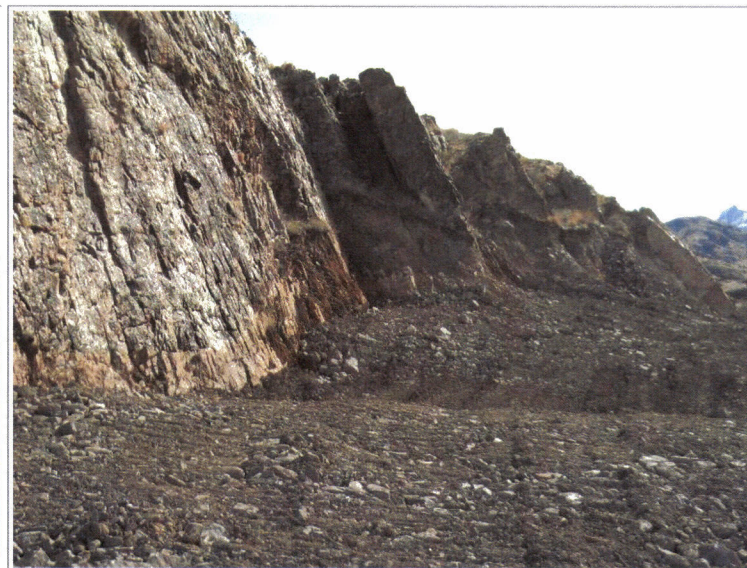
Largely reburied rock outcrops. Minor soil will slough off slopes in the rear.

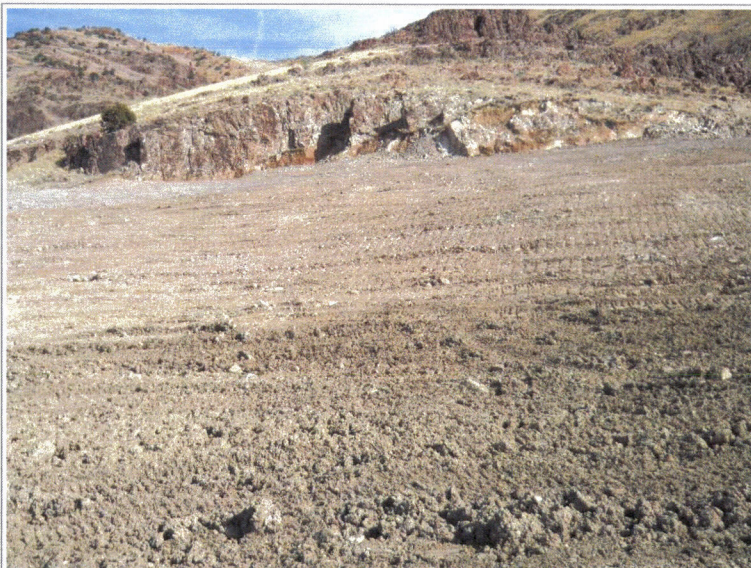
View looking up the graded slopes to the east. Note the smoothness.

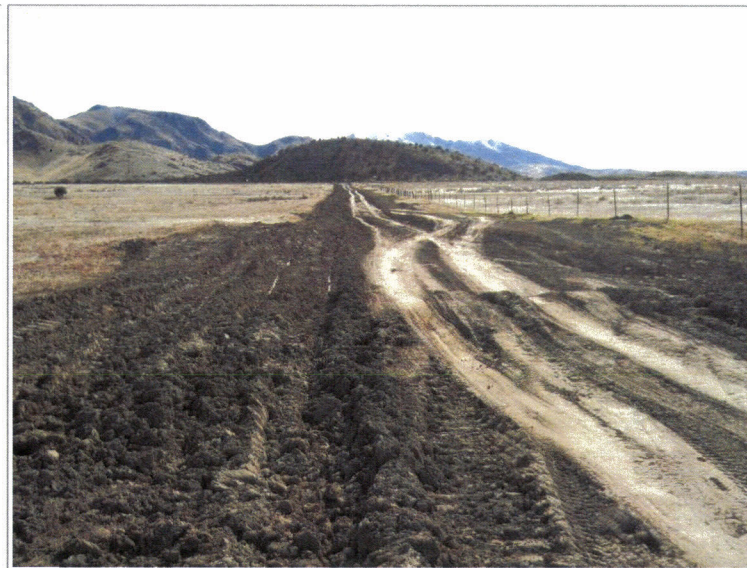
Haul road reduced by ripping the east side.
